DOT HS 806 849

Final Report

Side-Impact Aggressiveness Attributes MDB-To-Car Side Impact Test of a 26° Crabbed Moving Deformable Barrier to a 1981 Volkswagen Rabbit at 39.1 Mph The United States Government does not endorse products or manufacturers. Trade or manufacturers' names appear only because they are considered essential to the object of this report.

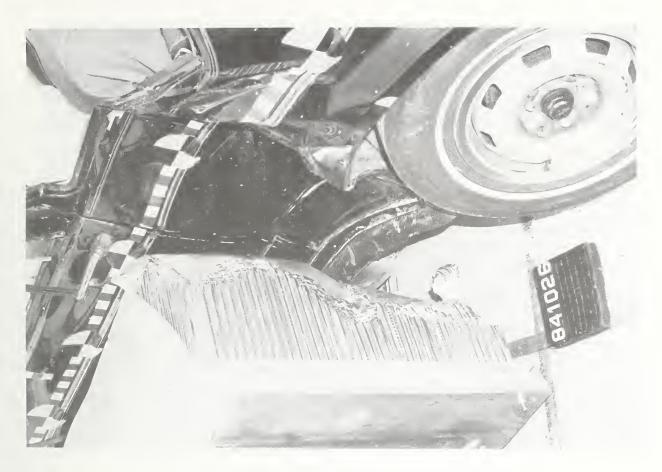
Figure A-23. POST-TEST VEHICLE DAMAGE ~ VIEW 2

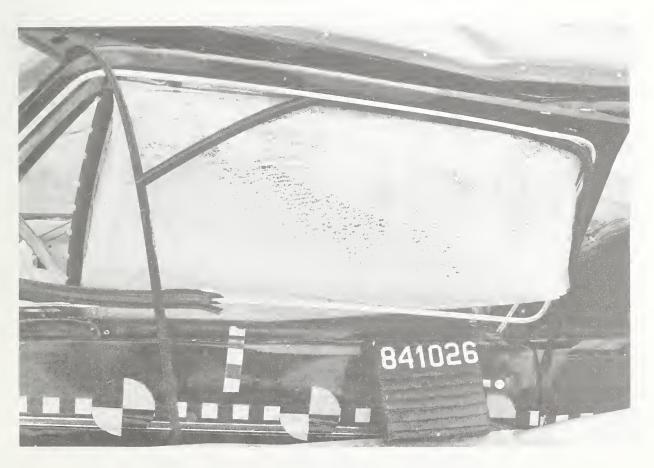
Figure A-24. POST-TEST MODIFIED WINDOW A-13
